J-47 JET ENGINE COMPRESSOR FAILURES

1 June 1950 - 31 December 1951

Office of The Inspector General, USAF
Norton Air Force Base, California

7 April 1952

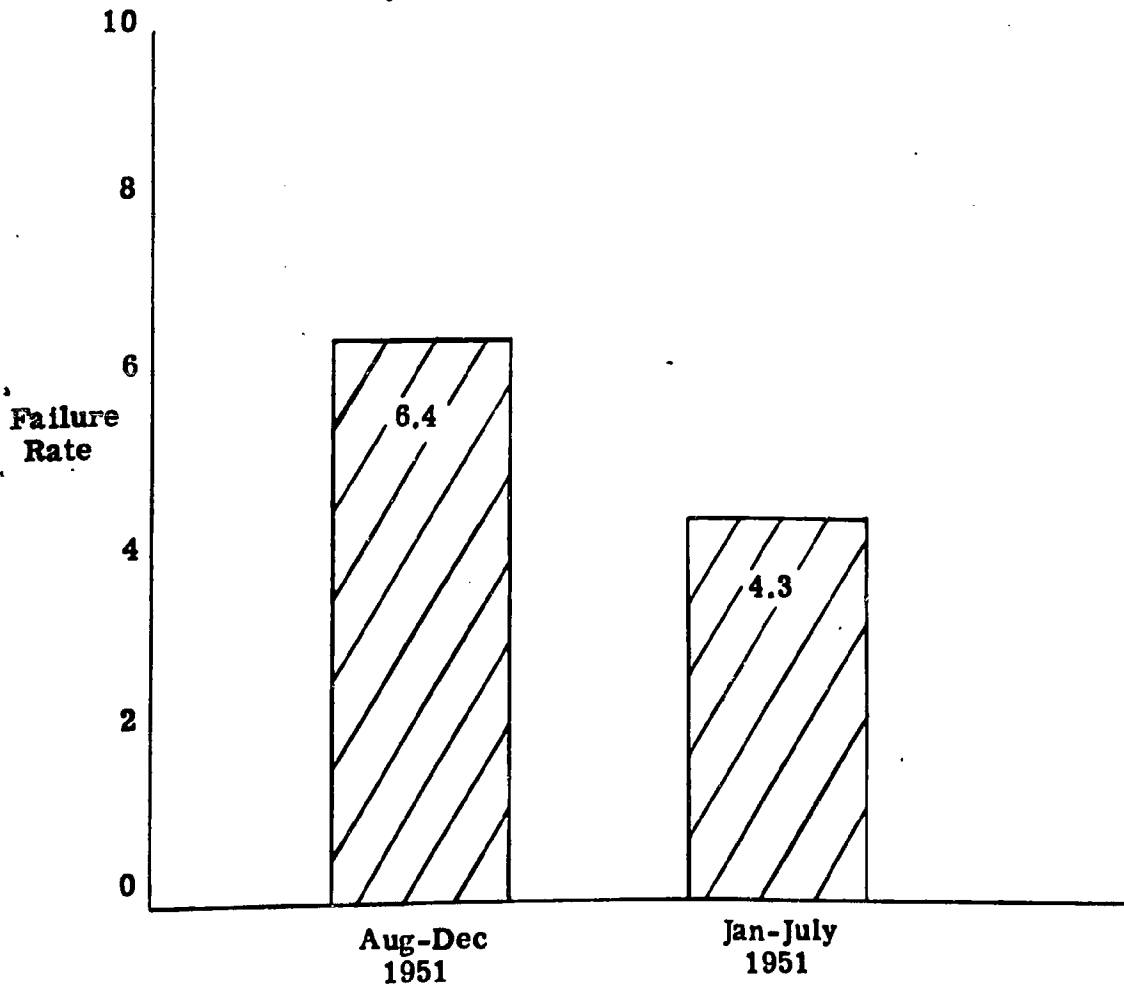
TABLE III

7. The statistics in paragraph 6 indicate that engine overhaul procedures could have been a factor causing the extremely high proportion of overhauled engine compressor failures as compared with new engine failures. All the engines involved in this study were overhauled at Oklahoma City Air Materiel Area prior to June 1951. Since that time the procedures used on the overhaul line at Oklahoma City Air Materiel Area have been extensively revised as a result of inspection by teams from the Office of the Deputy Inspector General, Air Materiel Command, Wright Air Development Center, and engine manufacturers. Several irregularities in the methods of overhauling J-47 engine compressors were noted. The compressor section was being assembled in the horizontal position rather than in the vertical position. This aggravated an already critical problem of misalignment. Damaged spacer ring pins were being removed by striking them with a hammer instead of pulling them with a force applied parallel to the axis of the hole. Excessive first stage clearances were being corrected by striking the first stage wheel with a hammer rather than by application of pressure in conjunction with a backing ring to distribute the pressure over the entire wheel rim area. Air Materiel Command instructions pertinent to the allowable compressor rotor and stator blade looseness have been amended. All of these revised procedures were placed in effect at Oklahoma City Air Materiel Area by authority contained in an Air Materiel Command teletype, MCMMP11-8-61-M, dated 15 August 1951 from the Maintenance Division. J-47 engine overhaul techniques at Oklahoma City Air Materiel Area have improved considerably since August 1951 (see Tab D).

1951 COMPRESSOR ACCIDENT RATES PER 100,000 ENGINE HOURS

JAN-JULY VS AUG-DEC
